**State of Louisiana
Coastal Protection and Restoration Authority**

2017 Annual Inspection Report

Fritchie Marsh Restoration

State Project Number PO-06
Priority Project List 2

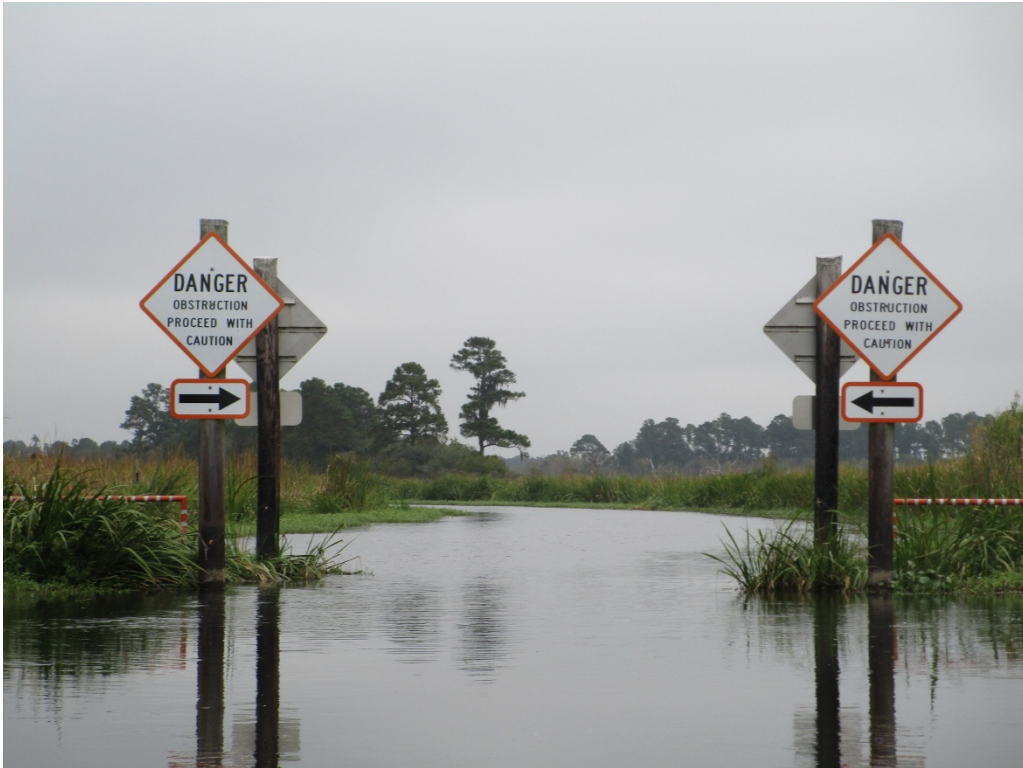
Photo 1: W-14 Weir and Warning Signs

The weir structure was mostly surrounded by aquatic vegetation, but the boat bay was navigable. The visible portion of the handrails appeared to be in good condition. The warning signs were in very good condition (Photo #1). No maintenance is required in this area at this time.

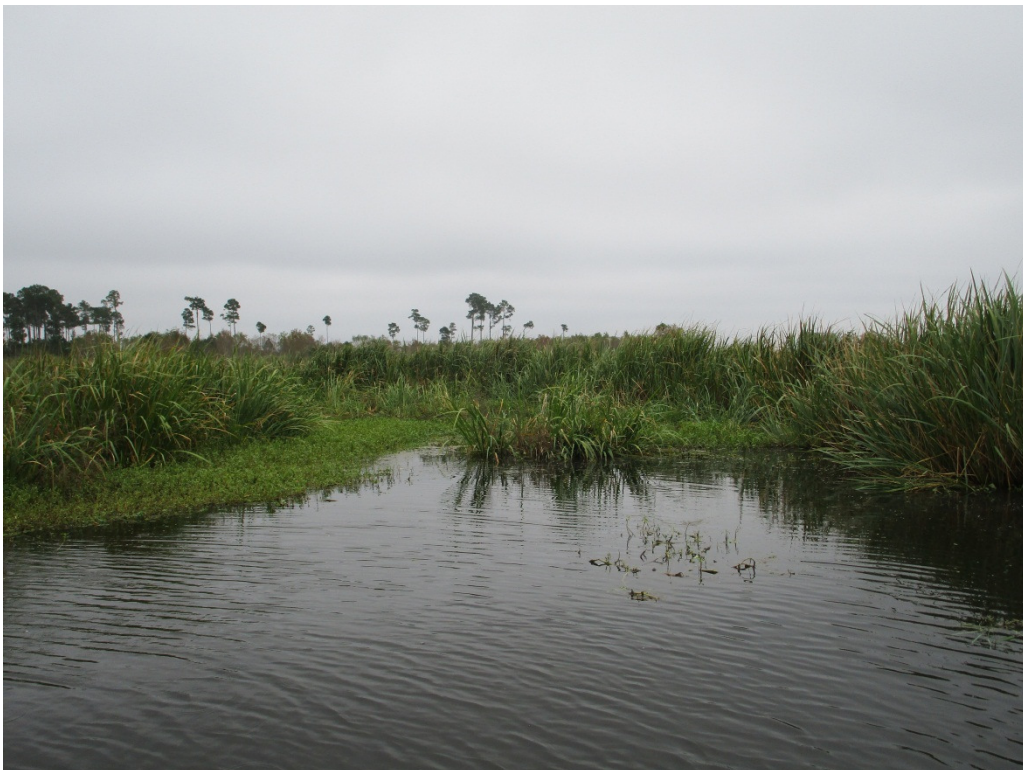
Photo 2: W-14 Diversion Canal

The channel inlet was filled in and unnavigable due to aquatic vegetation (Photo #2). Emergent aquatic vegetation was present in the channel outfall.

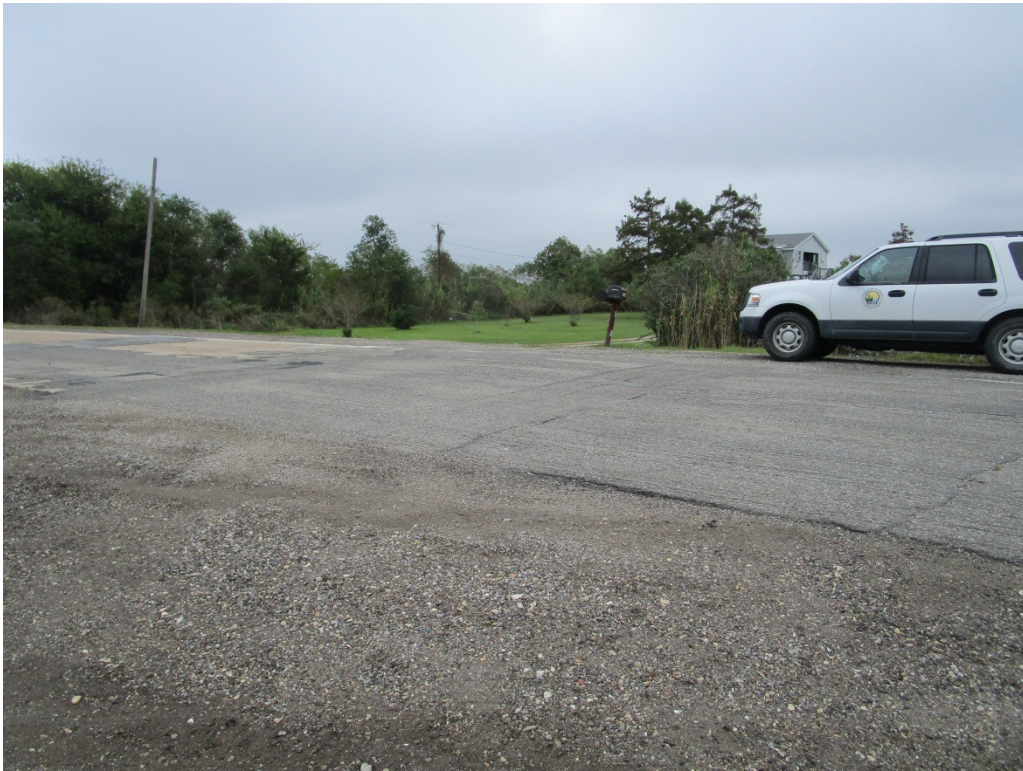
Photo 3: Hwy. 90 Road Surface Above Culverts

HWY 90 road surface	Good	None		3	No significant change since last inspection.

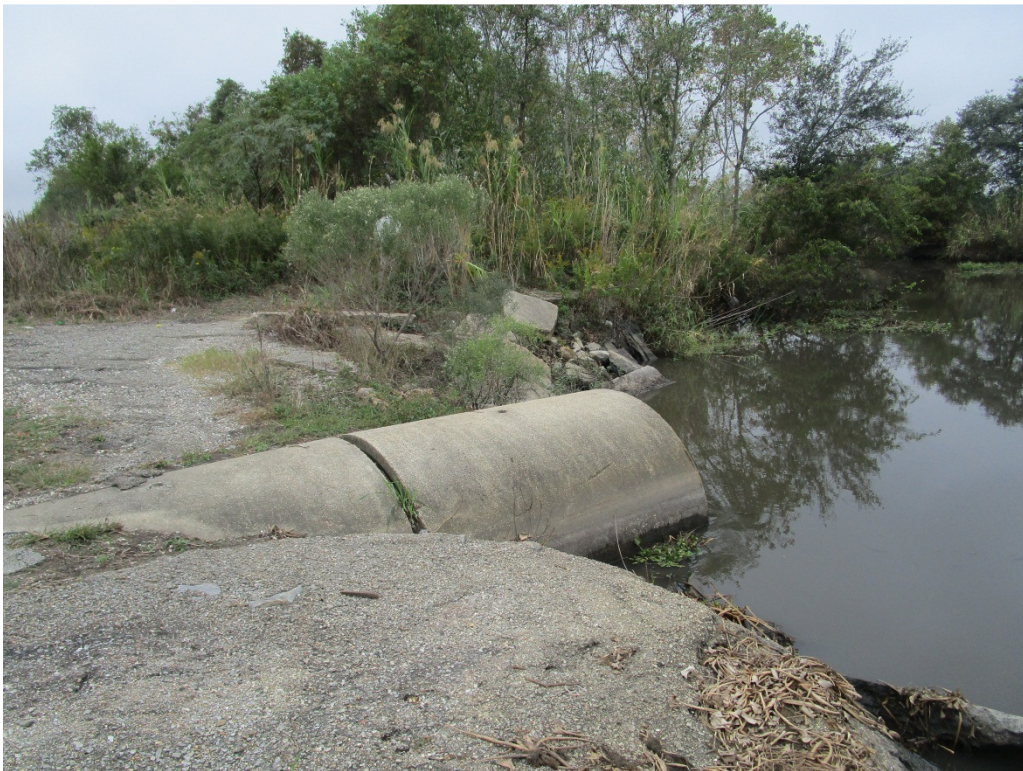
Photo 4: Culverts Below Hwy. 90

The joint in the culvert on the dredged side of the bayou appeared to be experiencing some separation (Photos #4 & #5). The bank scour reported in previous inspections appeared to have progressed very little, even with the extremely high water experienced during the Spring 2016 flooding. This area deserves continued observation during future inspections.

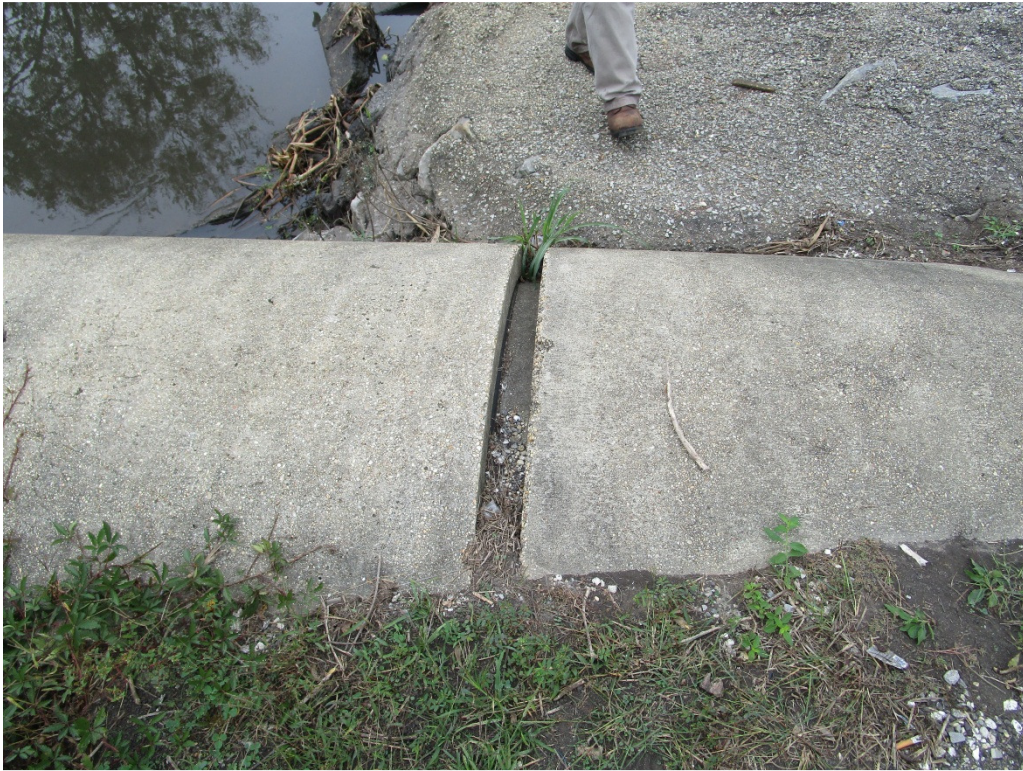
Picture 5: Joint of Culvert

Item	Condition	Physical Damage	Corrosion	Photo #	Observations and Remarks
Handrails, Grating, Hardware, etc.	Good	None	None	1	No significant defects noted.
Signage, Supports	Very Good	None	None	1	Signs and timber support piles appeared to be in very good condition.
RipRap channel lining	Good	None		4	Good condition. Rip-rap covered by concrete debris on South bank.
W-14 Weir structure	See remarks	See remarks		1	Structure was mostly hidden by emergent vegetation; strong flow was visible in channel.
W-14 diversion channel dredge	Fair	None		2	Channel entrance is filled in and unnavigable due to aquatic vegetation. Emergent vegetation was present in outfall.
Salt Bayou dredging	See remarks	N/A		6	Salt Bayou was deep and unobstructed for about 4,500 feet downstream (marsh side) of culverts at US Hwy 90. Siltation was noted beginning at approx. Sta. 45+00 and continued southwest to Sta. 53+00.
72" Diameter culvert	Fair	None		4,5	Appeared to be some separation at joint; water appeared to be flowing freely through culvert.

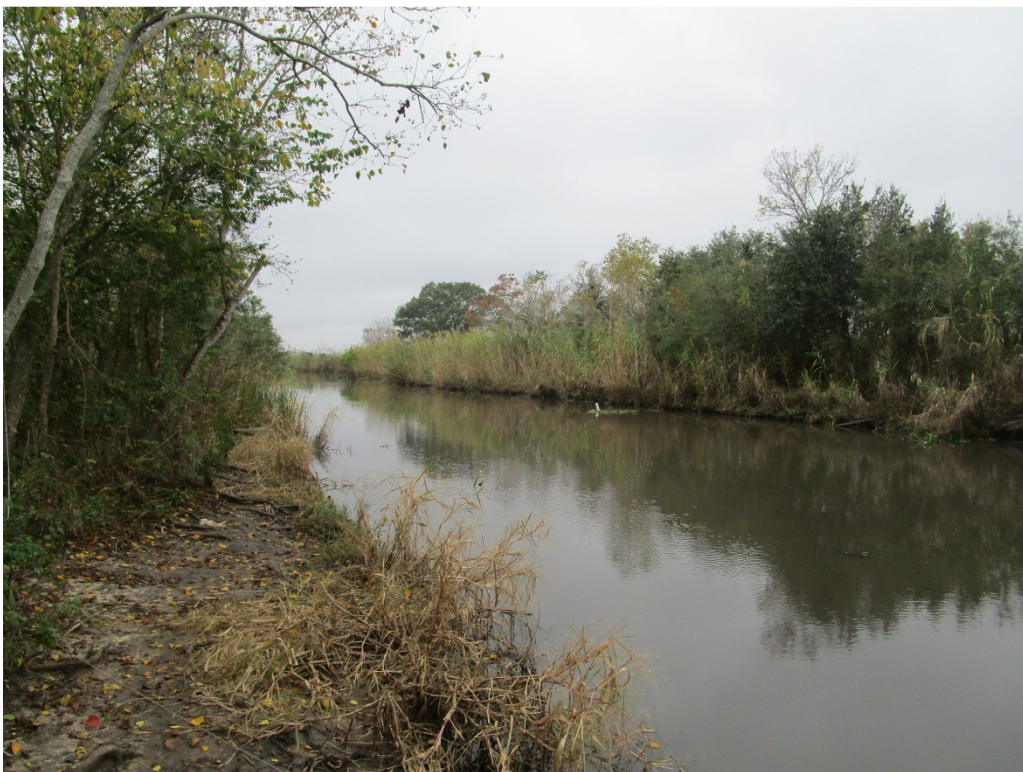
Photo 6: Salt Bayou Flowing into Project Area

The inspection team was not able to travel up Salt Bayou. An inspection in December 2015 determined that significant siltation of the bayou begins at approximately 4,500 feet downstream of the culvert and remains shallow for several thousand feet beyond the end of dredging at 5,300 feet downstream of the culvert. This condition appeared to be relatively unchanged. A steady flow of water was observed flowing into the project area (Photo #6).
